**GEOTECHNICAL INVESTIGATION
BETWEEN C.N. 1402 & 1420, LACROIX ROAD, HAMMOND, ONTARIO
F18-QT-2019-029
CITY OF CLARENCE-ROCKLAND**

The City of Clarence-Rockland
Attn: Mr. Charles Bonneau, Coordinator, Capital Projects
1560 rue Laurier Street
Rockland, Ontario
K4K 1P7

Lascalles Engineering & Associates Limited
1010 Spence Avenue, Suite 14
Hawkesbury, Ontario
K6A 3H9

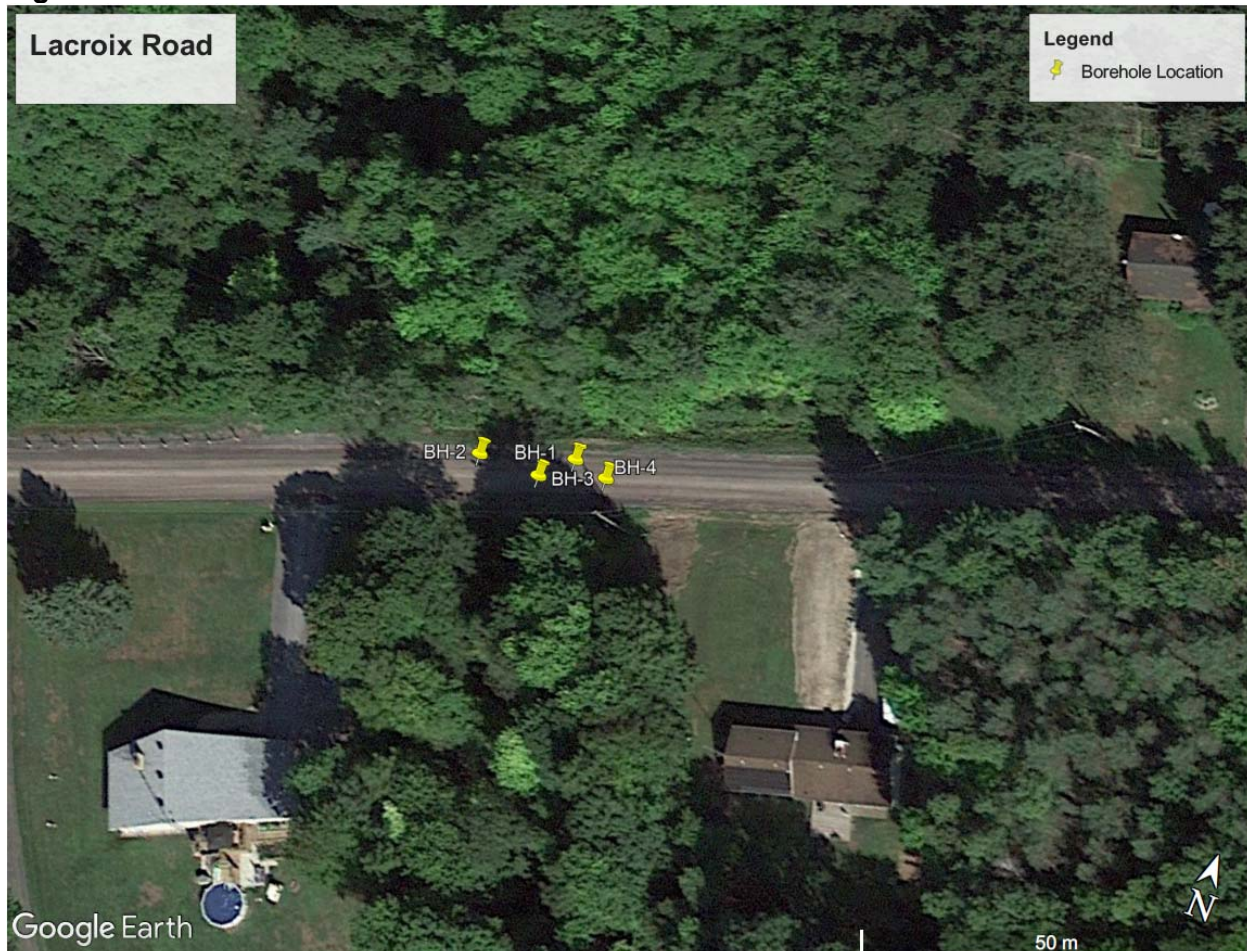
Figure 1: Borehole Location

All boreholes were located using a GPS (Global Positioning System) receiver using NAD 83 (North American Datum). Using these GPS coordinates, the borehole locations were plotted on a Google Earth aerial image as presented in **Figure 1**. The geodetic elevations of the boreholes were provided to Lascelles' technical staff at the time of the fieldwork by the project surveyor/consultant - Jp2g Consultants Inc. They also provided the elevation of the centreline of road (Elev. 73.184m) and the top of the culvert north side (Elev. 65.941). It is noted that the CSP culvert was measured on the north side to be 0.4m diameter.
